NASA TN D-4964

# DEVELOPMENT OF IMPROVED THROAT INSERTS FOR ABLATIVE ROCKET ENGINES

*by Jerry M. Winter and Donald A. Peterson*

*Lewis Research Center*

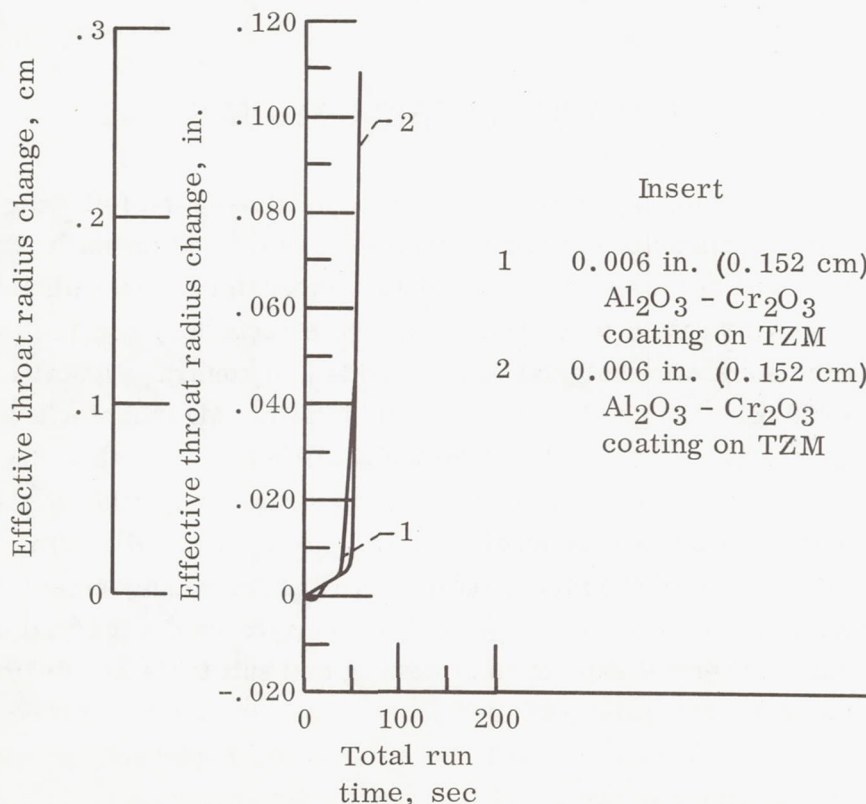
Figure 6. - Throat erosion for aluminum oxide - chromium oxide coated TZM inserts.

in figure 6, was caused by loss of the aluminum oxide - chromium oxide ( $\text{Al}_2\text{O}_3$  -  $\text{Cr}_2\text{O}_3$ ) coating followed by rapid oxidation of the unprotected TZM. Failure was primarily due to melting of the aluminum oxide layer. The coatings appeared to have adequate adhesion to the substrate. Unfortunately, the inserts were not run long enough to assess the suitability of the intermediate chromium layer at high-temperature, steady-state operation (because the aluminum oxide layer melted). Included in table VI(1) is a photograph of the fired insert number 1. The film supplement illustrates this type of failure.

Inserts 1 and 2 were tested for approximately 50 seconds when a rapid increase in the throat area of each insert was noted. This rapid increase in the throat area shown

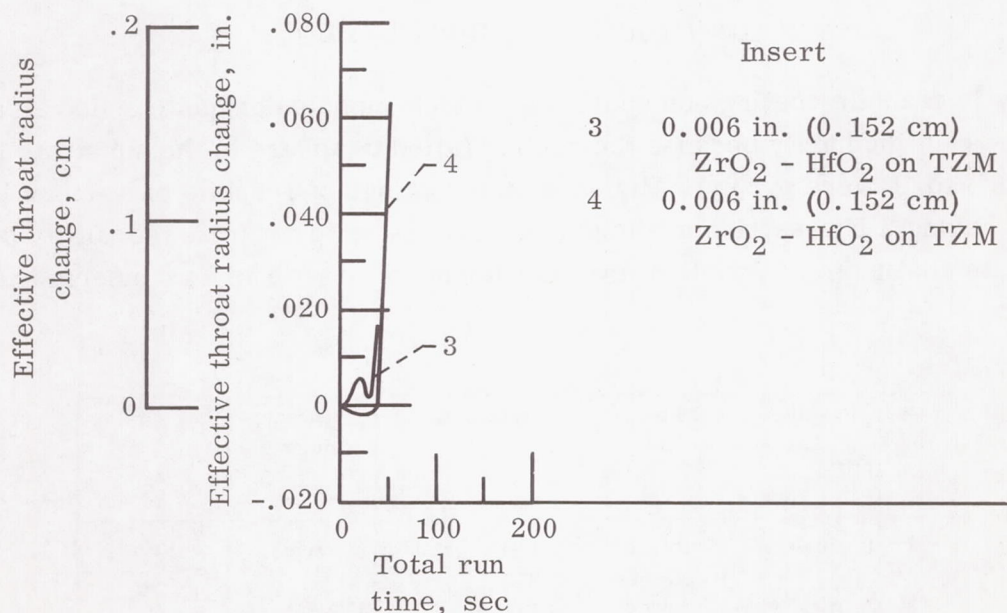
Figure 7. - Throat erosion for zirconium oxide - hafnium oxide coated TZM inserts.

Hafnium oxide - zirconium oxide on TZM. - A 0.006-inch (0.0152-cm) thick coating of hafnium oxide ( $\text{HfO}_2$ ) and zirconium oxide ( $\text{ZrO}_2$ ) over an intermediate layer of  $\text{ZrO}_2$  and chromium was also applied to a TZM substrate by the plasma arc spraying and gas-pressure bonding techniques. The firing data for inserts 3 and 4 are presented in figure 7. Failure of the coating was apparently due to vaporization of the chromium in the intermediate  $\text{ZrO}_2$ -Cr layer. This indicates that a more refractory material than chromium should be used for an intermediate layer. The film supplement also shows this failure.

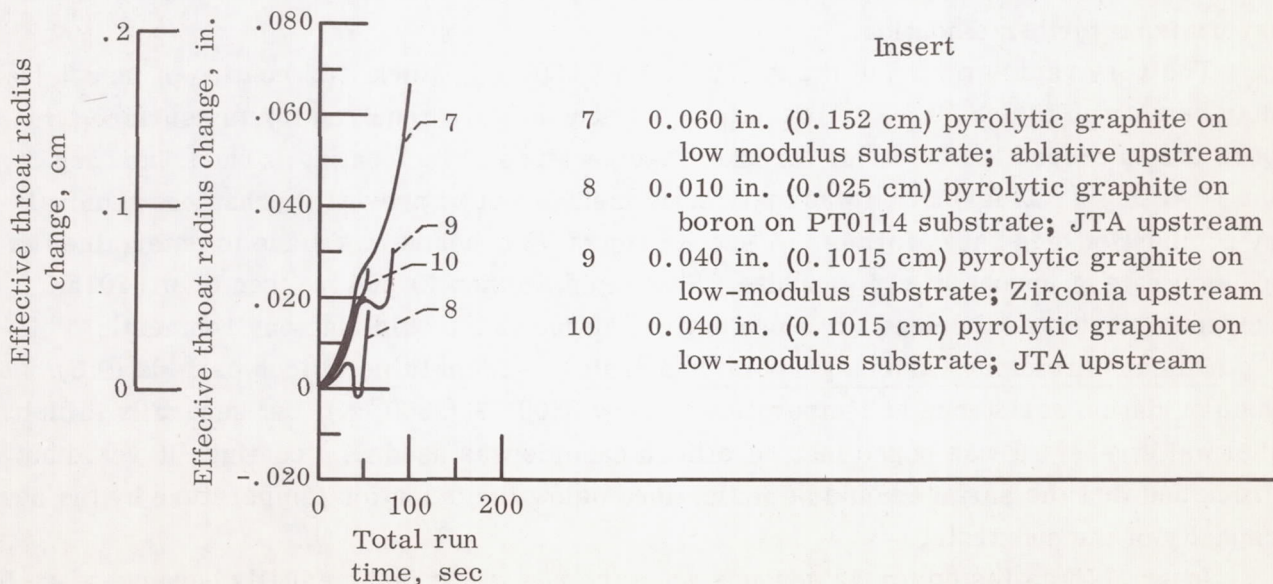
Figure 9. - Throat erosion for graphite-coated low-modulus-graphite-substrate inserts with upstream liners.

The firing results for all four inserts are presented in figure 9. Although insert 8 has only an 0.010-inch (0.0254-cm) thick coating compared with 0.060 inch (0.152 cm) for insert 7, the extended time (50 sec compared with only 20 sec) for throat erosion to

initiate in insert 8 was apparently a result of the increased oxidation resistance of the boron codeposition. Both coatings, however, lost adhesion at the leading edge as a first step to failure. For insert 7, the erosion of the upstream material (silica-phenolic) at the insert interface exposed the coating edge to the high-velocity gas stream with subsequent undercutting and attack on the substrate. When the upstream silica-phenolic material was replaced with a JTA liner for insert 8, undercutting at the insert interface did not occur. Both the coating and substrate for insert 8 cracked (see table II(8)), however, which led to oxidation of the substrate and subsequent failure of the coating. The high gas velocity experienced for insert 9 undoubtedly contributed to the premature removal of the coating in the upstream area.

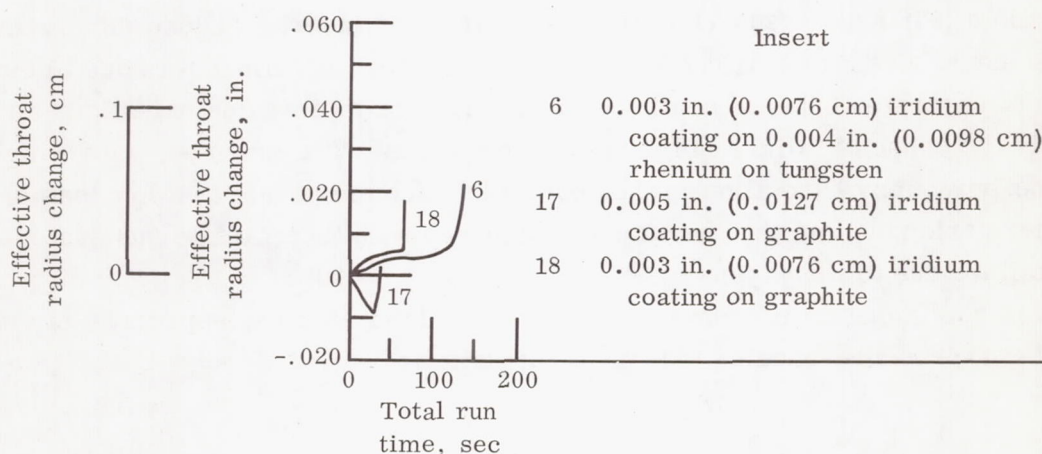
Figure 12. - Throat erosion for iridium coated substrate (graphite or tungsten) inserts.

The firing data are plotted in figure 12. The firing of both inserts was stopped when a rapid increase in the throat area (see fig. 12) was observed. The type of failure for

insert 17 is illustrated in table VI(17). Failure could be assigned to thermal stress due to a mismatch of thermal expansion or by diffusion oxidation. The negative slope recorded for insert 17 during the run could be explained by diffusion oxidation of the graphite substrate, causing carbon dioxide ( $\text{CO}_2$ ) gas pressure buildup between the coating and the substrate. The relatively porous structure of the iridium, inherent with the slurry dip process, may have allowed oxygen to diffuse through the coating, react with the graphite substrate to form volatile  $\text{CO}_2$ , which caused the coating to lose support, expand outward and finally burst. This would explain the rapid area change. Because the graphite

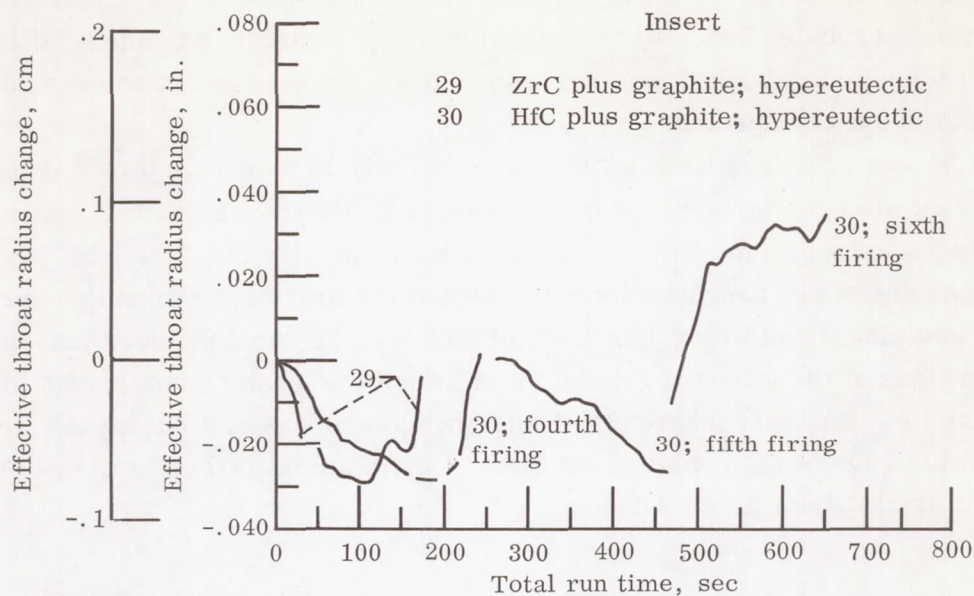
Figure 17. - Throat erosion for hyper-eutectic carbide inserts.

The firing data are presented in figure 17 for inserts 29 (ZrC plus graphite) and 30 (hafnium carbide (HfC) plus graphite). The first run of 25 seconds for insert 29 (ZrC plus graphite) was aborted because of a gas leak in the combustion chamber. The formation of an oxide layer reduced the measured throat radius approximately 0.025 inch (0.0635 cm). A second run was made for about 153 seconds at which time small pieces of the oxide layer came off at the throat. Excessive erosion at the upstream interface between the insert and the ablative material caused gas to flow around the outside diameter of the insert resulting in test termination (rapid area increase is shown in fig. 17). The final appearance of this insert (table VI(29)), however, indicates that the material has promise. No cracking or rapid removal of the oxidation products was experienced.

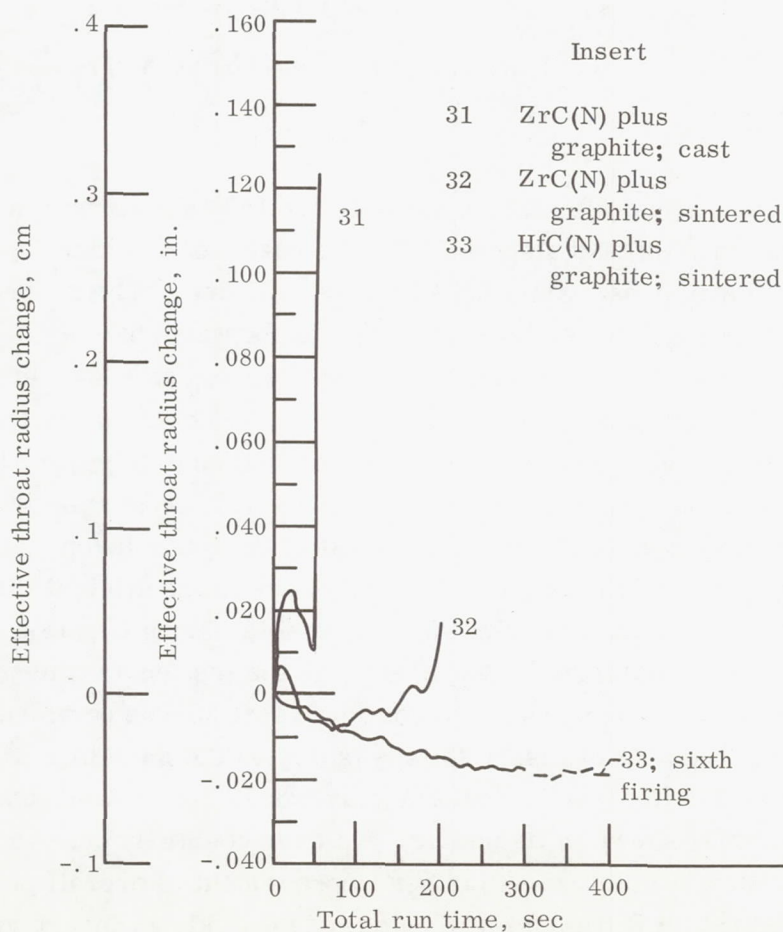
Figure 18. - Throat erosion of hypereutectic carbonitride inserts.

Insert 31 was prepared from a cast billet of  $\text{Zr}(\text{C}, \text{N})$  which contained less than 0.10 weight percent nitrogen (private communication from Battelle Memorial Institute). Insert 32 was made from a mixture of  $\text{ZrC}$  and zirconium nitride ( $\text{ZrN}$ ) which resulted in a final nitrogen content of approximately 1.0 weight percent after pressing and sintering. Figure 18 is a plot of the firing data for both inserts. It was concluded that the case insert, regardless of the nitrogen content, was inferior in erosion resistance to the hot-pressed sample. The cast insert (31) disintegrated and was lost during the firing. Insert 32 ran for 200 seconds prior to erosion. Only nominal circumferential cracking was observed after shutdown (table VI(32)).

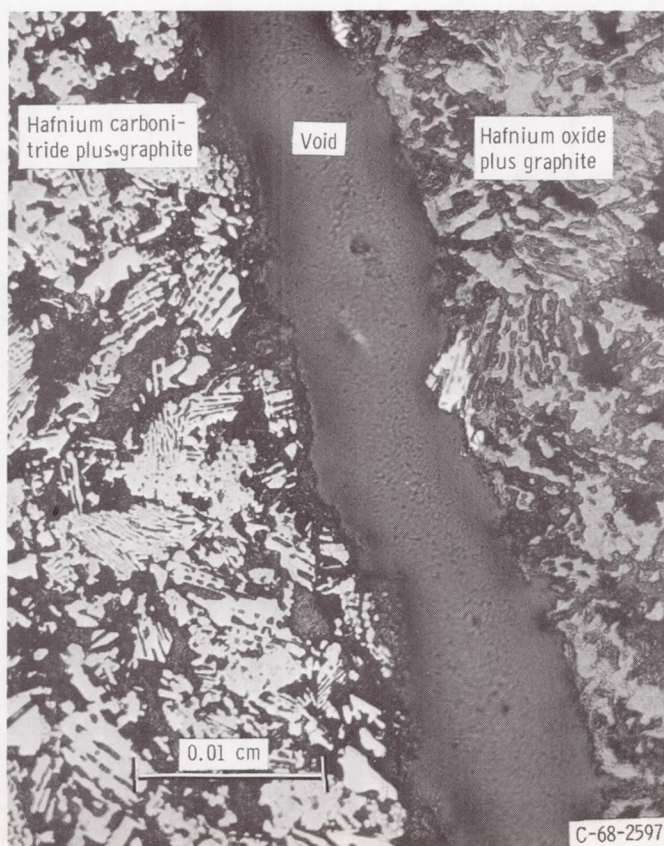
Figure 19. - Postfiring photomicrograph of hafnium carbonitride insert (33).

The surface layer contained many small fissures or checks which did not extend into or degrade the primary material structure. Surface checking is caused by thermal stresses in the relatively weak chemical reaction zone which is formed in place during rocket firings. Mechanical erosion could result from spallation of surface particles when the local shear forces exceed the shear strength in the reaction zone. The difference between the oxidized layer and the material underneath is shown in figure 19. The bond between the two materials was weak with an excess of carbon in the area. Further development should be concentrated on strengthening the oxide layer and eliminating the cause of

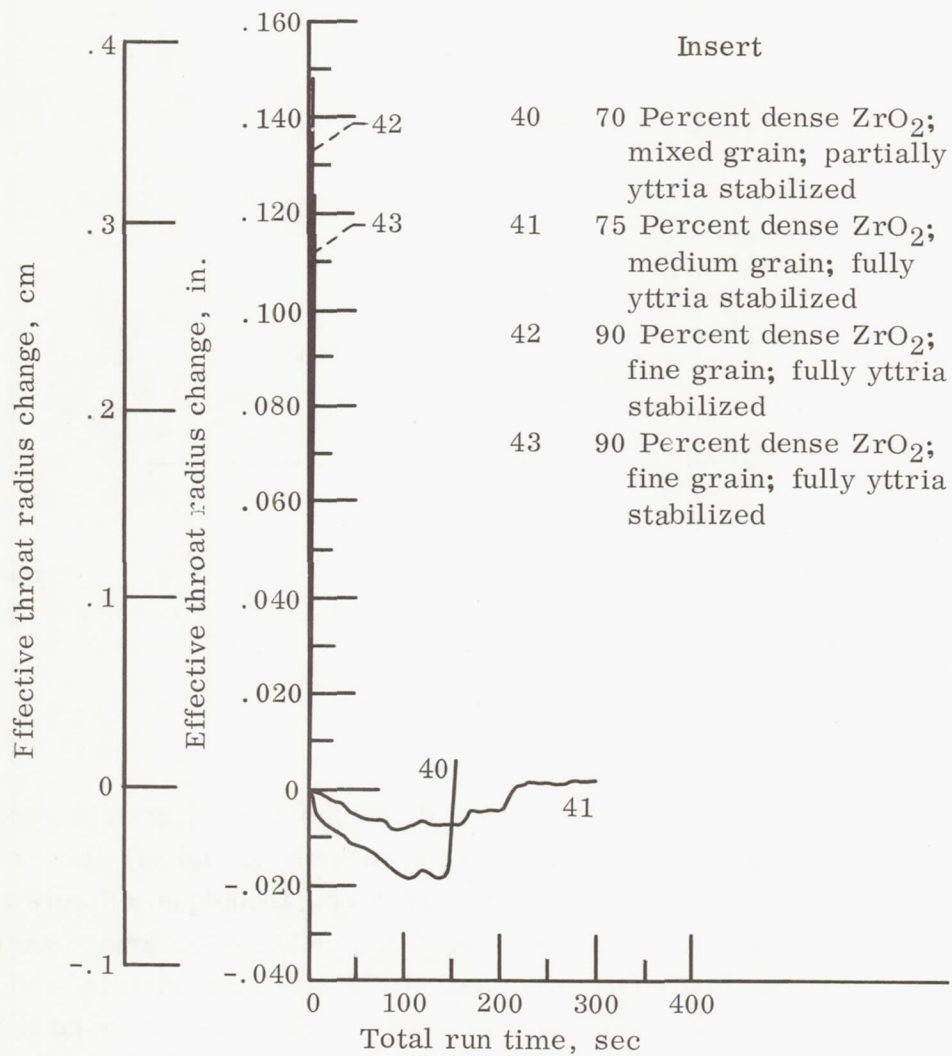
Figure 23. - Throat erosion for yttria stabilized zirconium oxide inserts.

Zirconium oxide-yttria stabilized. - Zirconium oxide is a very interesting material for use in the storable-propellant environment. Its melting temperature in excess of  $4500^\circ\text{F}$  ( $2750\text{ K}$ ) and its high resistance to oxidation together with high strength make it very attractive. Unfortunately, unalloyed  $\text{ZrO}_2$  is highly susceptible to thermal stress cracking. When unstabilized pure  $\text{ZrO}_2$  is heated, the crystalline structure changes from monoclinic to tetragonal, which results in a volume decrease. To prevent cracking, which is associated with this volume change, from taking place, various stabilizing agents have been tried. Calcium oxide is one of the most commonly used stabilizers and has been effective for low heat-flux environments. It has not proved successful where the heat flux has been large, as is typical in a rocket engine. The Air Force has experimented with the use of rare earth oxides as stabilization agents for  $\text{ZrO}_2$  (ref. 5). Recently, yttria ( $\text{Y}_2\text{O}_3$ ) was shown to be quite promising. Four yttria-stabilized inserts were evaluated (inserts 40 to 43). Inserts 40 and 41 were compacted to approximately 75 percent theoretical density, and inserts 42 and 43 had a density of 90 percent. The low-density

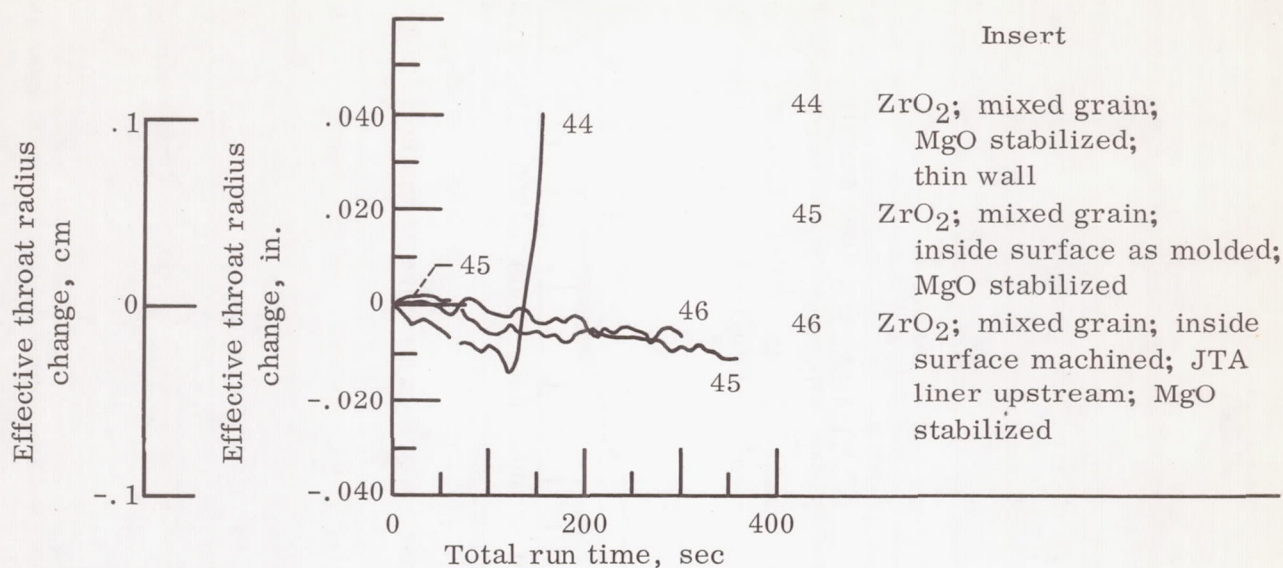
Figure 24. - Throat erosion for sintered, mixed-grains size zirconium oxide inserts.

Zirconium oxide, sintered, mixed grain size. - The firing data for three  $ZrO_2$  inserts (44 to 46) are presented in figure 24. All three inserts were hot pressed from a mixed-grain-size, magnesia-stabilized mix. The outside of insert 44 was machined to have approximately one-half the wall thickness of the other two inserts in an attempt to minimize thermal stresses. A 0.250-inch (0.508-cm) thick RVC graphite sleeve was used as a backup material for insert 44. Slight axial and circumferential cracks were observed on the inside surface after the initial 60-second firing. The second firing of insert 44 resulted in loss of the insert throat section. Note the rapid increase in throat radius shown

in figure 24 and the post-test photograph in table VI(44). This is also the type of catastrophic failure observed when structural failures occur in larger throat sizes (ref. 2).

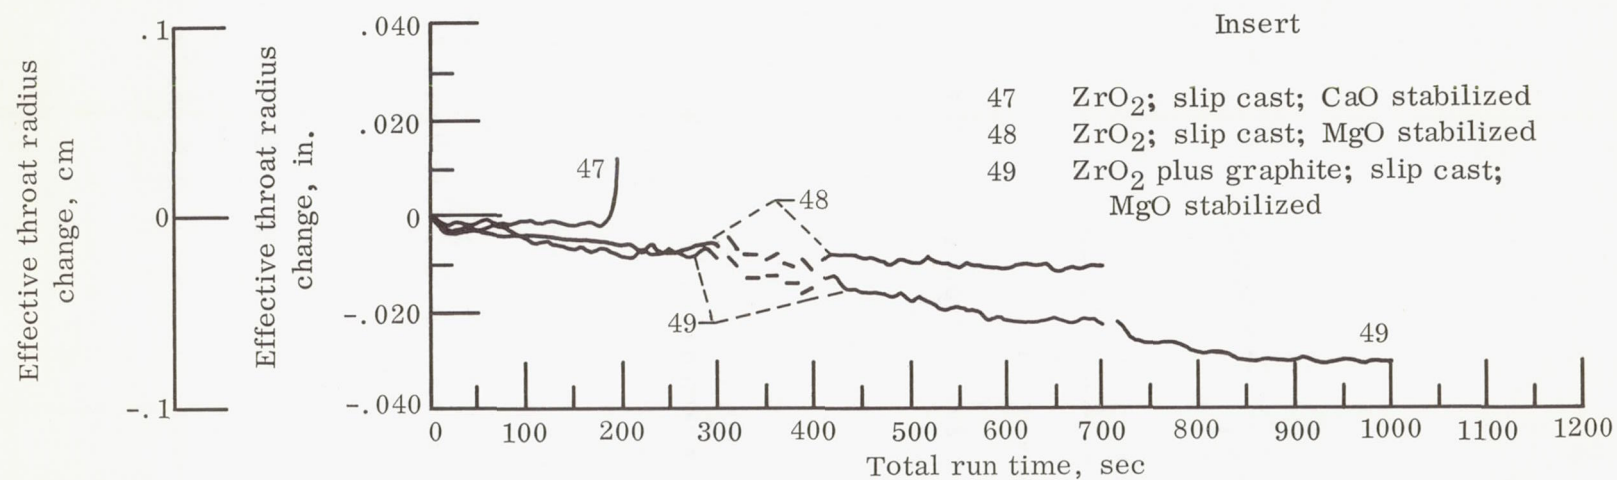
Figure 25. - Throat erosion for slip-cast, mixed-grain-size zirconium oxide inserts.

Zirconium oxide, slip cast mixed-grain size. - Insert 47 was prepared from slip-cast ZrO<sub>2</sub> stabilized with calcium oxide (CaO); the stabilization agent used for 48 and 49 was magnesium oxide. The importance of stabilizing ZrO<sub>2</sub> is due to the volume change

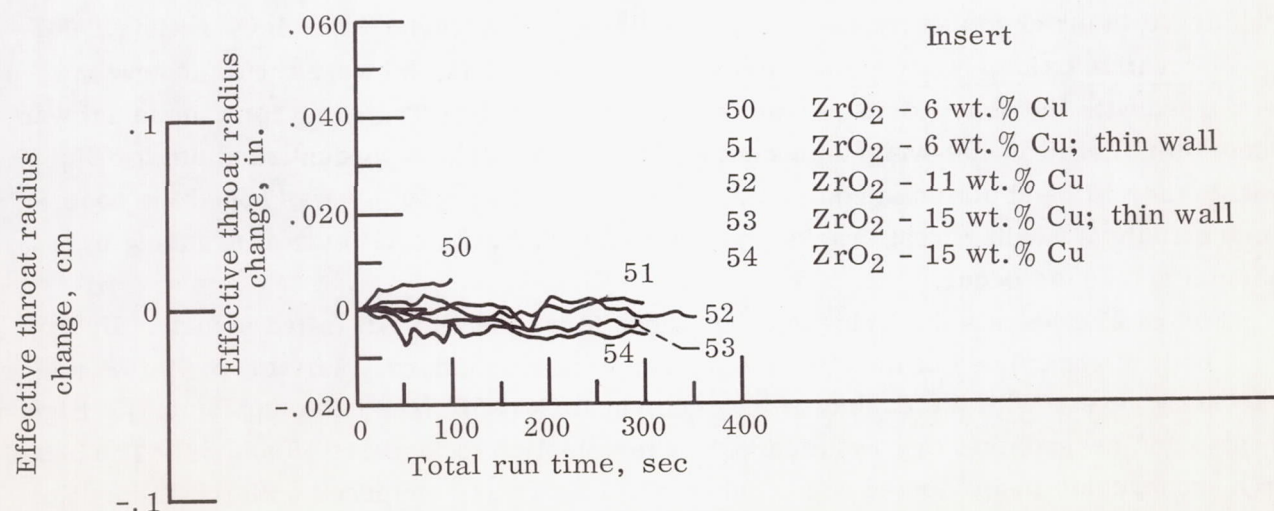
Figure 26. - Throat erosion for zirconium oxide - copper inserts.

Zirconium oxide-copper (anion deficient). - Five proprietary (unpublished data from S. Brown, Rocketdyne Div. of North American Aviation Corp.) anion deficient  $\text{ZrO}_2$  inserts were test fired. Copper was added to the  $\text{ZrO}_2$  matrix to increase the thermal shock resistance. The variables investigated were copper content and insert wall thickness. Firing data for inserts 50 to 54 are presented in figure 26.

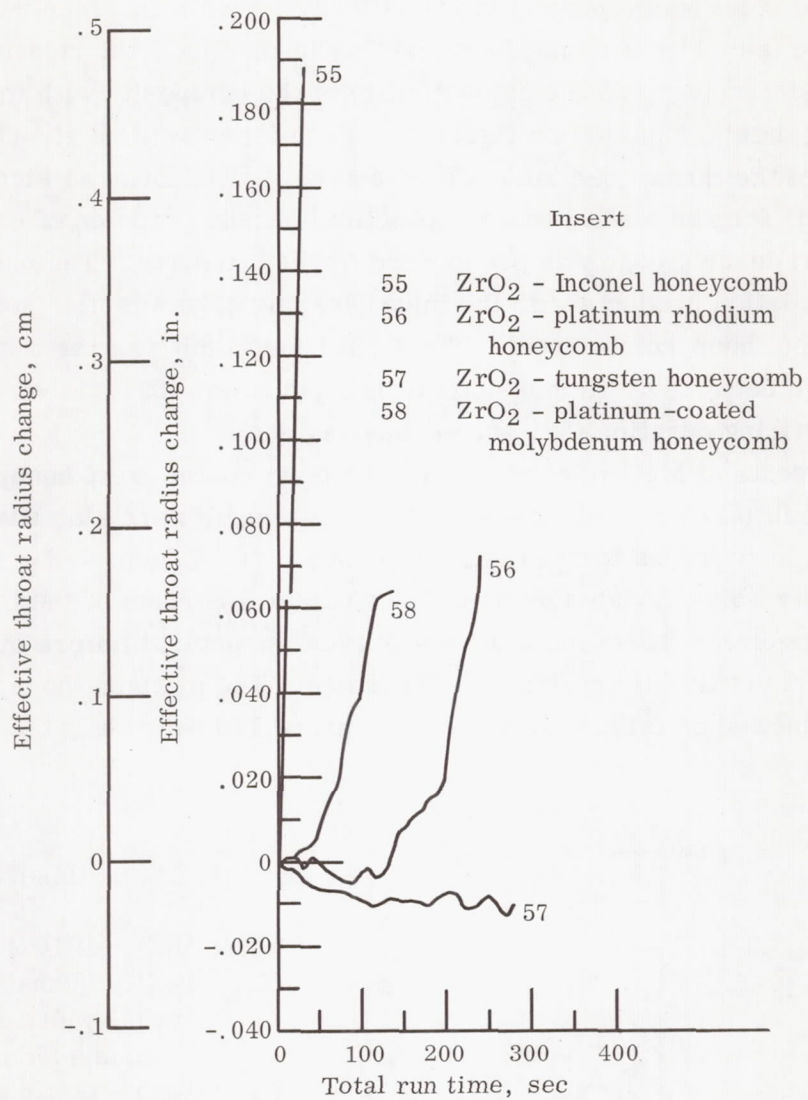
Figure 27. - Throat erosion for honeycomb reinforced zirconium oxide inserts.

Figure 27 presents the firing data for these four inserts. All failed structurally to some degree regardless of the reinforcing honeycomb employed. Surface spallation was extremely severe with the Inconel reinforcement (insert 55) (see film supplement). High erosion and severe cracking resulted in test termination for inserts 56 and 58. The best  $\text{ZrO}_2$ -honeycomb insert tested was number 57, which was reinforced with tungsten. No throat erosion was measured but cracking and loss of material downstream of the throat precluded further testing (table VI(57)).

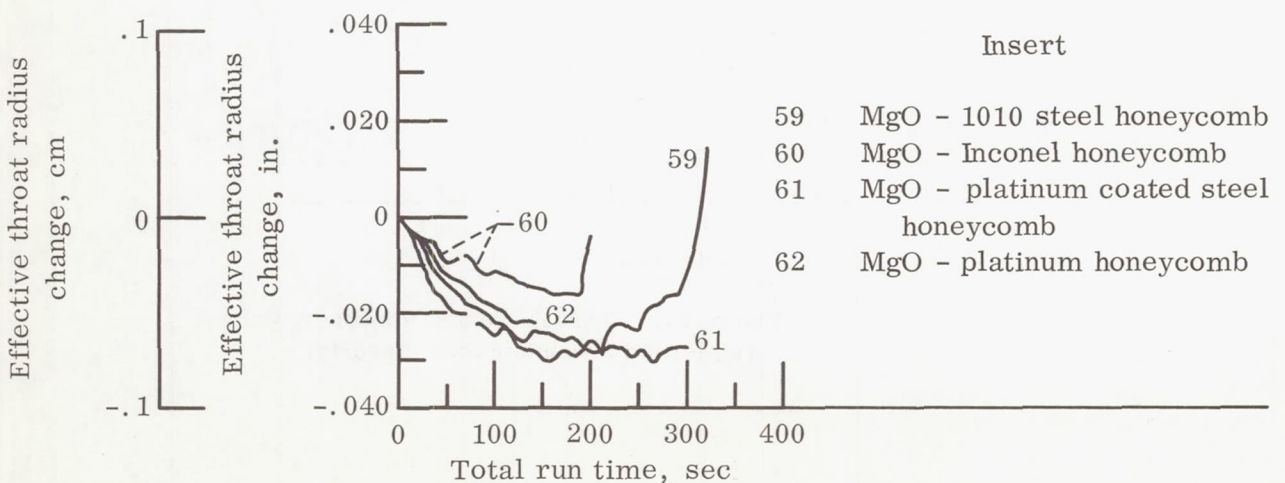
Figure 28. - Throat erosion for honeycomb reinforced magnesium oxide inserts.

Additional inserts of MgO reinforced with platinum coated steel honeycomb (61) and platinum honeycomb (62) were fabricated. The firing results are also shown in figure 28 and the post-test photographs are in table VI(61) and (62). Leading-edge failure and chemical reactivity was alleviated by using a JTA liner upstream of the throat insert. The platinum-coated steel honeycomb did not prevent structural failure of the ceramic matrix of insert 61 but throat erosion was prevented. The platinum honeycomb reinforced MgO (insert 62) showed no failure over the run time of 143 seconds. Unfortunately, fail-

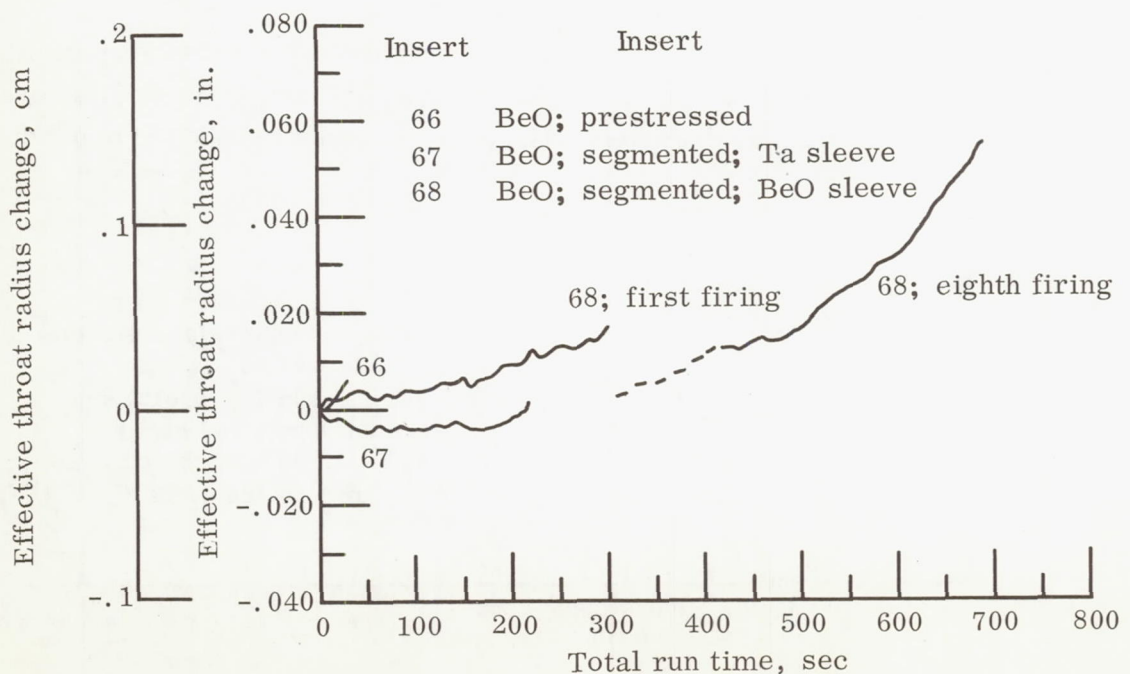
Figure 30. - Throat erosion for beryllium oxide inserts.

In order to prevent a tantalum-BeO reaction, another insert was designed with a 1/4-inch (0.635-cm) thick conical BeO sleeve on the outside to retain the segments. This insert (number 68) was tested for 691 seconds with structural cracking of the segments leading to the erosion shown on figure 30. Structural problems were first noticed after

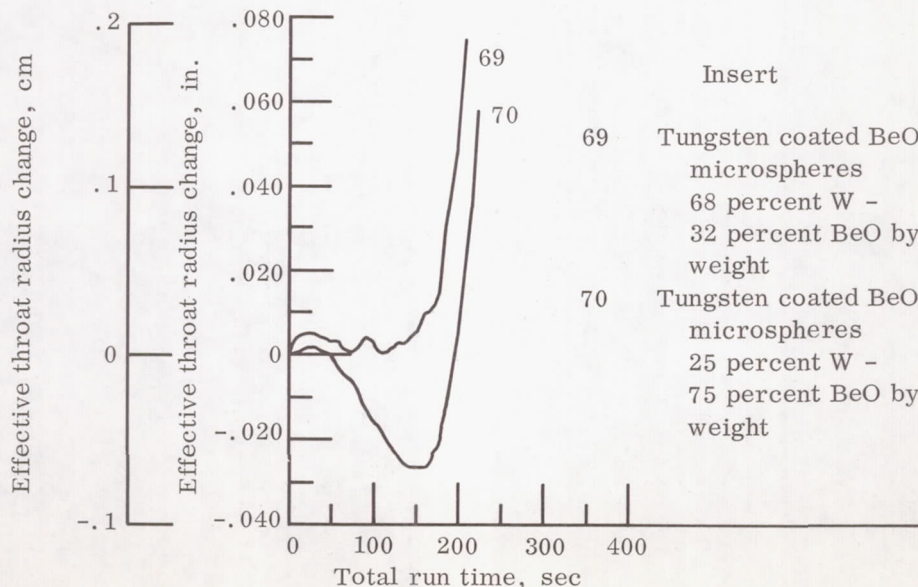
Figure 31. - Throat erosion for tungsten coated beryllium oxide microspheres.

The tungsten content for insert 70 was reduced to 25 weight percent. The throat erosion shown on figure 31 was not significantly improved over the erosion of insert 69. Pre- and post-test photomicrographs of insert 70 are shown in figure 32(b). The tungsten matrix is no longer continuous and a large number of voids are seen. The erosion failure of insert 70 was thought to be due to structural failure of the relatively porous BeO accentuated by oxidation of the tungsten.

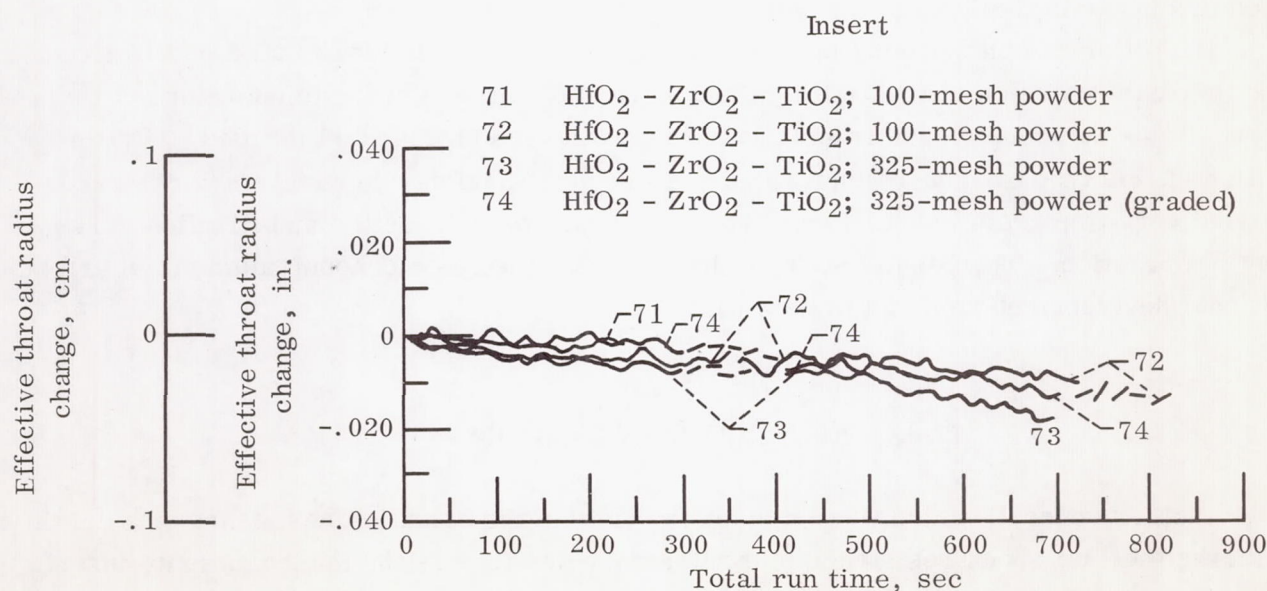
Figure 33. - Throat erosion for hafnium oxide - zirconium oxide - titanium oxide inserts.

Figure 33 presents the firing data for inserts 71 to 74. The inserts were prepared by mixing  $\text{HfO}_2$ ,  $\text{ZrO}_2$ , and  $\text{TiO}_2$ . The mixture was pressed, reaction sintered and pulverized, then isostatically pressed and resintered. Because of a firing malfunction during the scheduled 300-second run of insert 71, the run was terminated after only 229 seconds. It was decided to section the insert at this time in order to make a decision as to what composition would be best for insert 72. No cracks, melting or erosion were observed, and insert 72 was made identical to insert 71. To assess the long-term capabilities, an initial run of 358 seconds was made. Again, no cracking, melting or erosion was observed and a second firing was made for 365 seconds. After a total firing time of 723 seconds, a few minor surface fissures were noted. Three 20-second runs were then made, but the insert was not inspected between runs. After the fourth and fifth 20-second runs, the insert was inspected in the test cell. The six axial cracks which appeared after the fourth 20-second run were more severe and accompanied by some circumferential

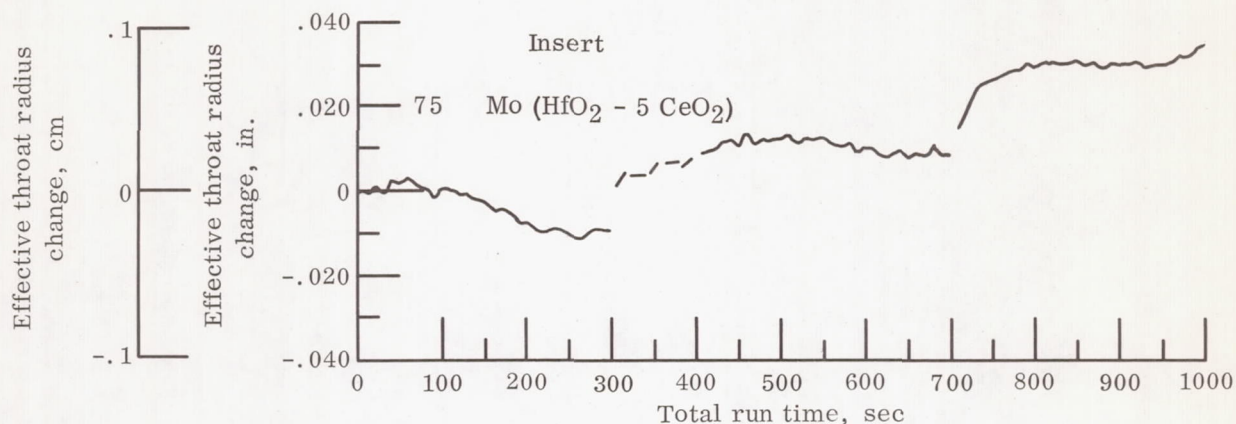
Figure 34. - Throat erosion for macrolaminate insert.

Nozzle 75 was composed of a macrolaminate structure of molybdenum and  $\text{HfO}_2$  with cesium oxide ( $\text{CeO}$ ) added as a bonding agent. The composite consisted of discrete layers of  $\text{HfO}_2$  and molybdenum within each macroparticle. The firing results are shown on figure 34. This insert was the only one tested that survived the 700-second duty cycle with neither cracking nor appreciable erosion. A final 300-second firing produced the erosion

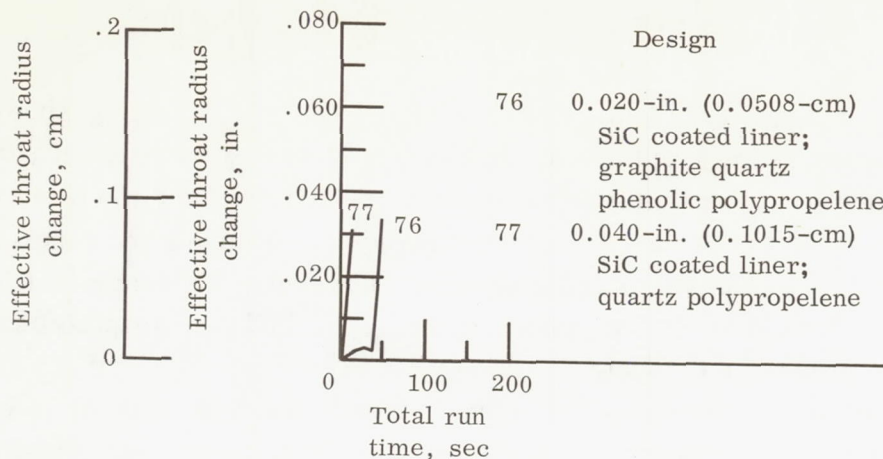
Figure 36. - Throat erosion for pyroconvective nozzle designs.

The design concept consisted of a refractory SiC coated graphite liner, grooved on the outside diameter, and backed with a gas reservoir structure. The reservoir system of nozzle design 76 was a composite of quartz and graphite fibers impregnated with a polypropylene-phenolic binder. The binder volatilized on heating and provided cooling gas which escaped through holes in the liner, located downstream of the throat plane. The reservoir system for nozzle 77 did not contain graphite fibers and was different in other respects including the elimination of the downstream holes. A comparison of configurations D and E (fig. 5(d) and (e)) illustrates the design differences between 76 and 77. Figure 36 presents the firing data for the two nozzles. Both nozzles failed by cracking of the composite liner probably within the first few seconds of firing time. Residual stresses

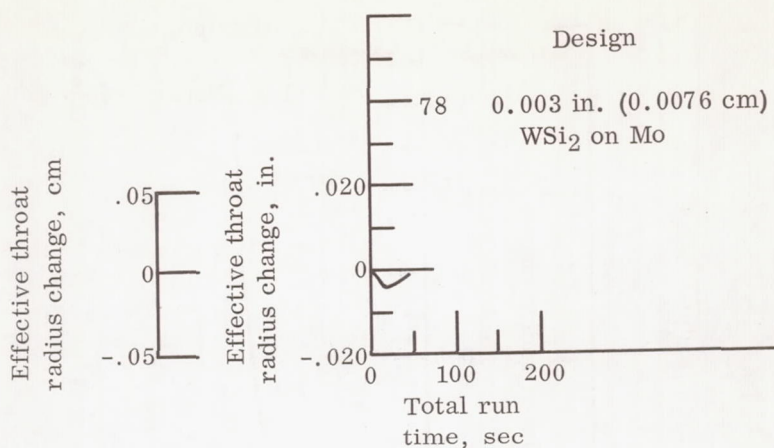
Figure 37. - Throat erosion for tungsten disilicide coated molybdenum nozzle design.

The nozzle test was terminated after 45 seconds because of a combustion gas leak. The throat erosion data are on figure 37. Inspection of the nozzle revealed partial removal of the coating by a combination of melting and oxidation. The extent of coating loss and oxidation of the molybdenum substrate may be seen in table VI(78). The failure indi-

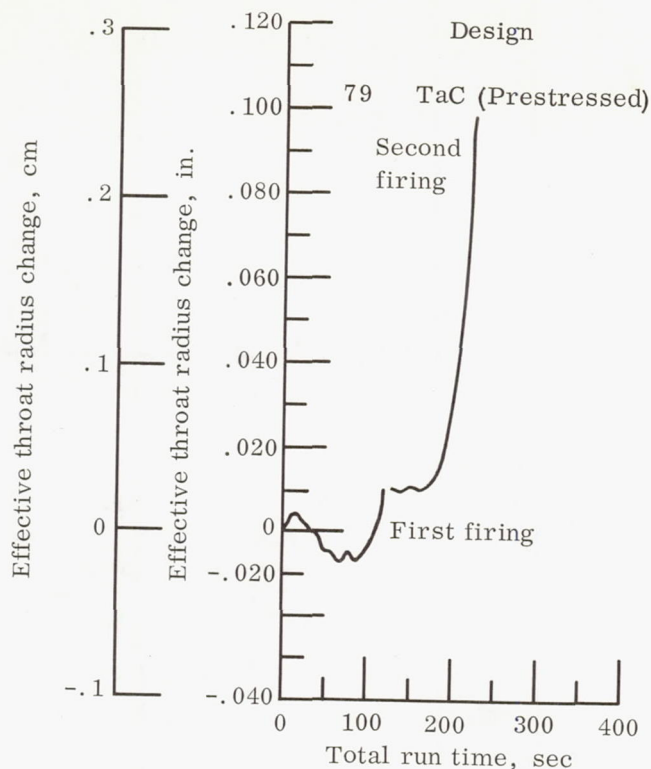
Figure 38. - Throat erosion for prestressed tantalum carbide nozzle design.

The test firing produced throat erosion as shown in figure 38. The erosion as shown in the film supplement was due primarily to oxidation. A second firing was made to measure the oxidation rate and the effect of restart on the prestressed design. The insert was not cracked following the initial firing. After the second firing, however, axial cracks were found in the insert (see table VI(79)). The cracking illustrates the difficulty of maintaining elastic behavior of material combinations whose properties are not precisely known. The nozzle design attempted to control the oxidation of the tantalum carbide insert by keeping the surface temperature below 3700<sup>0</sup> F (2310 K) for a 300-second

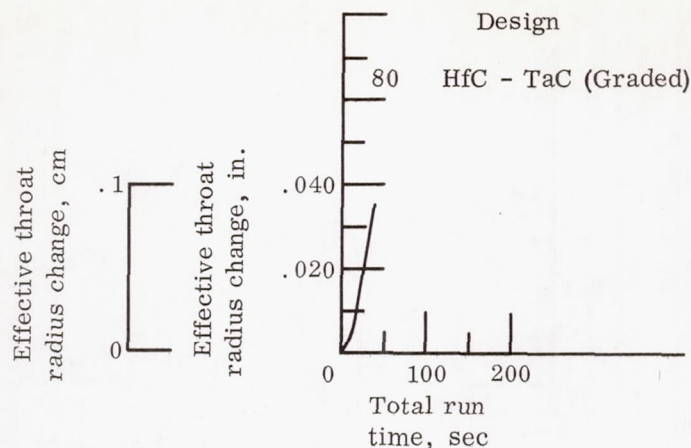
Figure 39. - Throat erosion for hafnium carbide - graded tantalum carbide nozzle design.

Figure 5(h) details the graded carbide design concept used for nozzle 80. The design consisted of four carbide layers with varying graphite content. The firing data, presented in figure 39, indicates a rapid erosion failure. Post-test inspection of the insert (table VI(80)) showed two circumferential cracks completely through the insert as well as numerous axial cracks. Although some pieces were lost from the insert during firing, the major contribution to throat erosion was oxidation of the HfC on the inside surface. The thickness of the HfC remaining at the throat was about 0.070 inch (0.178 cm). Adding the 0.035-inch (0.089-cm) erosion gives a layer 0.105-inch (0.267-cm) thick at the throat compared with the 0.100-inch (0.254-cm) design value. The other layers, however,

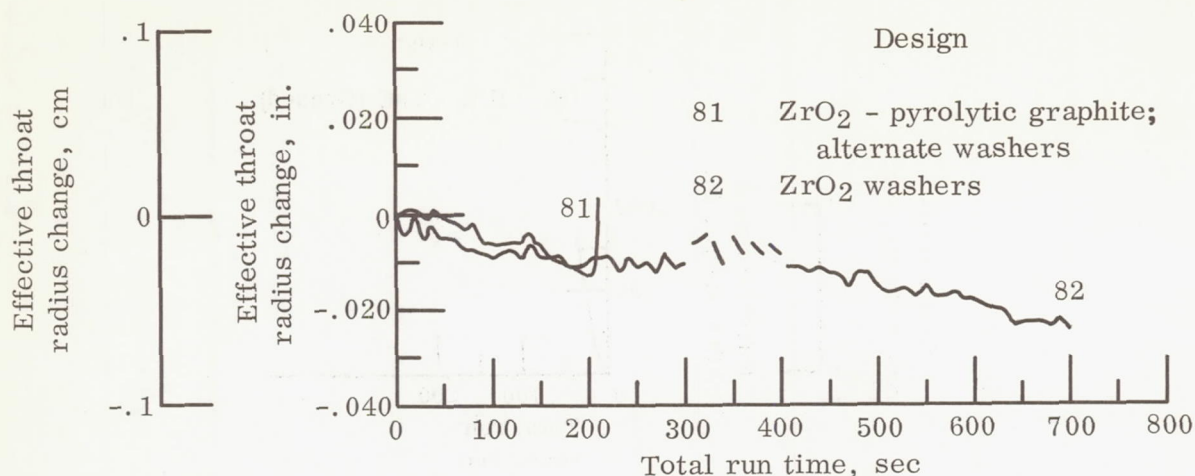
Figure 40. - Throat erosion for pyrolytic graphite laminated zirconium oxide washers.

Nozzle design 81 was composed of alternate axial washers of  $\text{ZrO}_2$  and pyrolytic

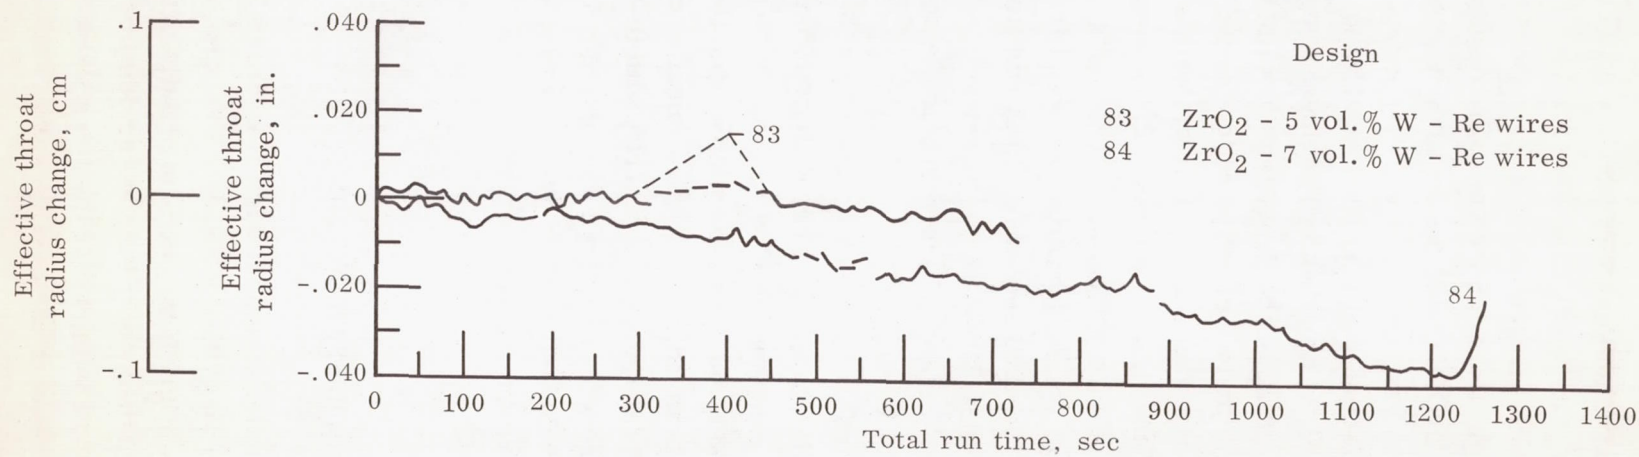
Figure 41. - Throat erosion for tungsten-rhenium wire reinforced zirconium oxide.

Figure 5(j) is a sketch of the design used for nozzles 83 and 84. Nozzle 83 contained 5-volume-percent and nozzle 84 contained 7-volume-percent tungsten - 3-weight-percent rhenium wires dispersed in a  $ZrO_2$  matrix. Wire diameter was 0.0035 inch (0.0089 cm) and wire length was nominally 3/16 inch (0.476 cm). Figure 41 presents the firing data. Both inserts survived the required duty cycle with no erosion and only minor surface spallation. However, both were cracked after the first 300-second cycle.

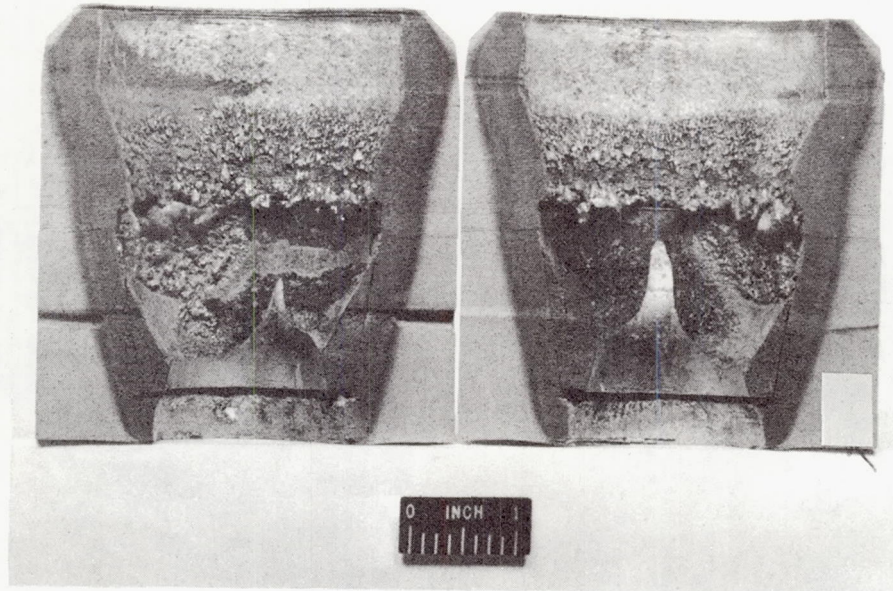
(7) Insert 7; injector 1A

Material		Form		Manufacturer	Configuration (a)	Additional layers
Coating	0.060-in. (0.1522-cm) pyrolytic graphite		a-b plane axial		American Metal Products	A	None
Insert	Pyrolyzed graphite cloth-phenolic		90° centerline				
Envelope	Silica phenolic (MX 2641)		90° centerline		Fiberite	4-in. (10.15-cm) o.d.	None
Run	Chamber pressure, P <sub>c</sub>		Oxidant-fuel ratio, O/F	Run time, sec	Total change in effective throat radius, ΔR		Remarks
	psia	kN/m <sup>2</sup>					
					in.	cm	
117	101.8	701	2.16	99.6	0.069	0.175	Leading edge failure; shutdown at first sign of coating failure at throat

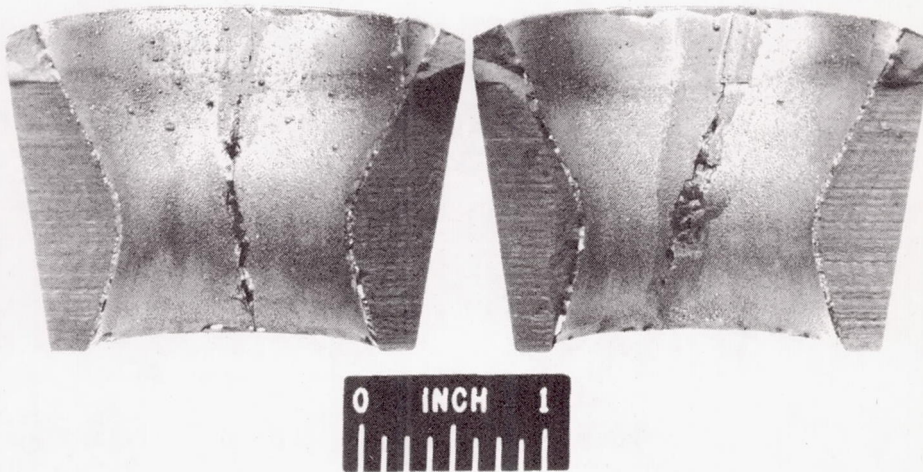
(12) Insert 12; injector 1A

Material	Form	Manufacturer	Configuration (a)	Additional layers
Coating		0.050-in. (0.127-cm) SiC	Pyrolytic	Dow Corning	A	None
Insert		UT-6 graphite	-----			
Envelope		Silica phenolic (MX 2641)	90° centerline	Fiberite	4.0-in. (10.15-cm) o.d.	None
Run	Chamber pressure, $P_c$		Run time, sec	Total change in effective throat radius, $\Delta R$		Remarks
	psia	kN/m <sup>2</sup>		in.	cm	
267	96.1	661	12.2	0.010	0.0254	Coating cracked, slight substrate erosion: shut-down at first sign of coating failure

Insert 12 was tested for 12 seconds when the run was ended manually because of a sudden increase in flow rate. No erosion data are plotted because of the short firing time. The coating (0.050-in. (0.127-cm) thick on insert 12) cracked as a result of ther-

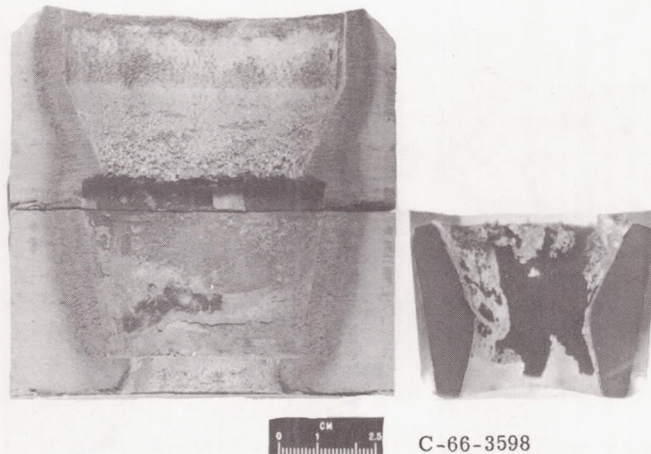
(18) Insert 18, injector 1A

Material		Form		Manufacturer		Configuration (a)		Additional layers	
Coating		0.003-in. (0.0076-cm) iridium		Slurry dip		Union Carbide		A		None	
Insert		Graphite		High-thermal expansion coefficient							
Envelope		Silica phenolic (MX 2641)		90 <sup>0</sup> centerline		Fiberite		4-in. (10.15-cm) o.d.		None	
Run	Chamber pressure, P <sub>c</sub>		Oxidant-fuel ratio, O/F	Run time, sec	Total change in effective throat radius, ΔR		Remarks				
	psia	kN/m <sup>2</sup>			in.	cm					
268	102.1	704	2.01	71.0	0.005	0.0127	Partial coating loss; shutdown at first sign of coating failure

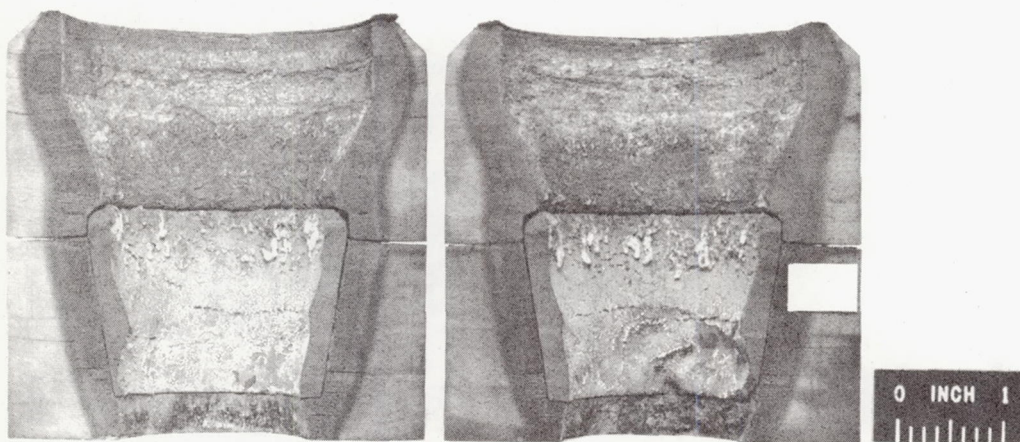
(19) Insert 19; injector 1A

Material	Form	Manufacturer	Configuration (a)	Additional layers
Insert		SiC-ZrC coated graphite powder with 20 % Zr base resin binder	Sintered	Magnesium Aerospace	A	None
Envelope		Silica phenolic (MX 2641)	90° Centerline	Fiberite	4-in. (10.15-cm) o.d.	None
Run	Chamber pressure, $P_c$		Run time, sec	Total change in effective throat radius, $\Delta R$		Remarks
	psia	kN/m <sup>2</sup>		in.	cm	
204	99.5	686	65.5	0.224	0.569	High erosion; shutdown

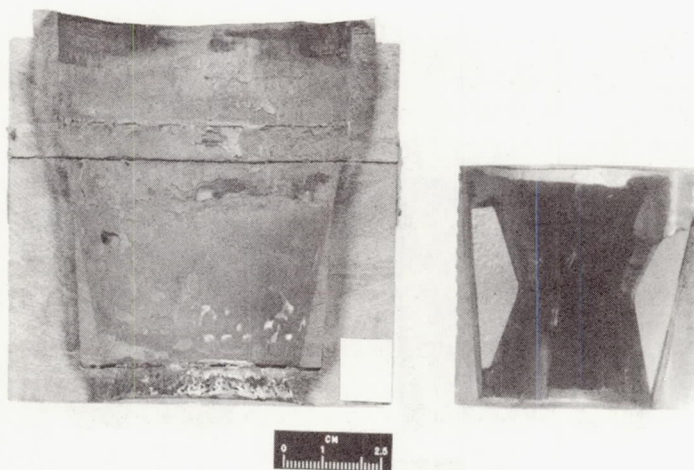
(25) Insert 25; injector 2

Material	Form	Manufacturer	Configuration (a)	Additional layers
Insert		Pyrolytic graphite: inside diameter, wedges outside diameter, cone	a-b plane radial and axial a-b plane axial and circumferential	Super Temp	B	1/8-in. (0.32-cm) thick Ta ring
Envelope		Silica phenolic (MX 2641)	90° centerline	Fiberite	5-in. (12.7-cm) o.d.	None
Run	Chamber pressure, $P_c$		Run time, sec	Total change in effective throat radius, $\Delta R$		Remarks
	psia	$\text{kN/m}^2$		in.	cm	
426	100.8	694	73.4	0.036	0.0865	Shutdown due to rapid erosion
